FY05 Forest Service Aviation Accident Review

NTSB Identification: **DFW05FA086**

NTSB Identification: **DEN05TA113**

NTSB Identification: **LAX05GA243**

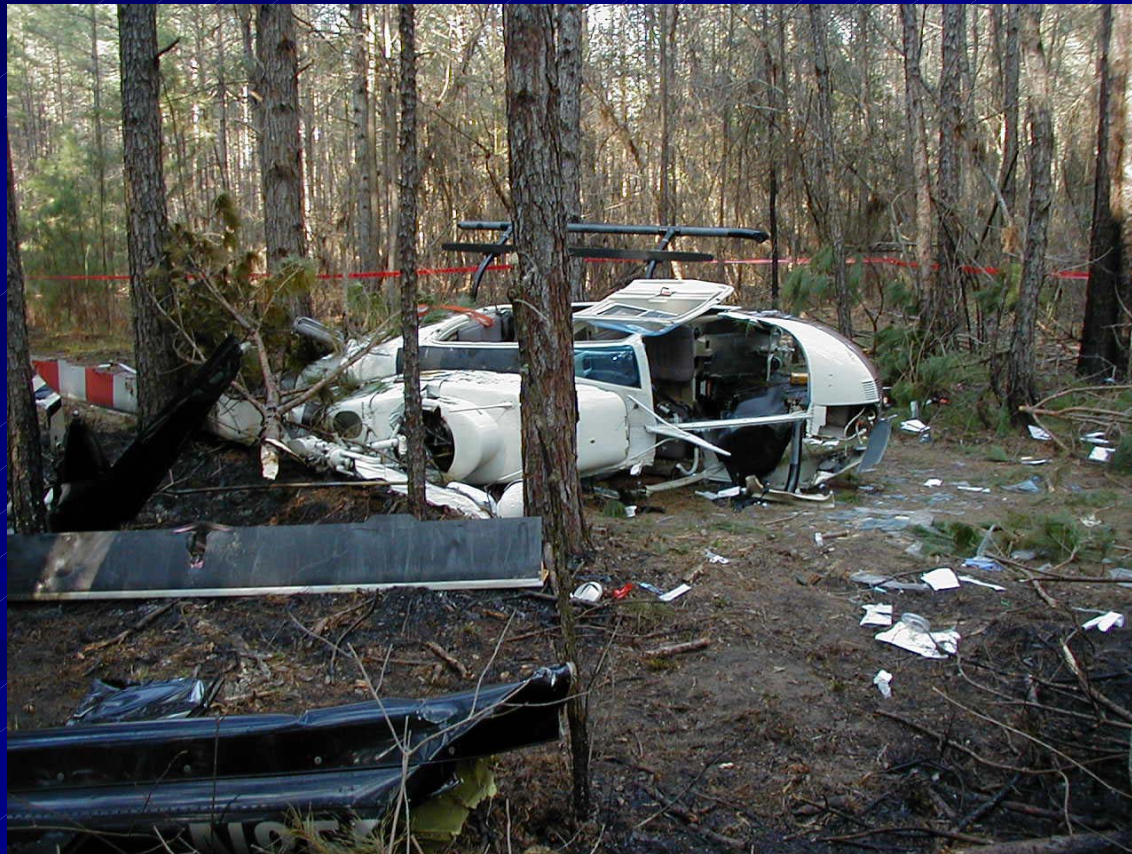
Accident occurred March 10, 2005 in Shelbyville, TX

Aircraft: Bell 206 BIII

Fatalities: 3

Operational Control Region 8, Sabine NF

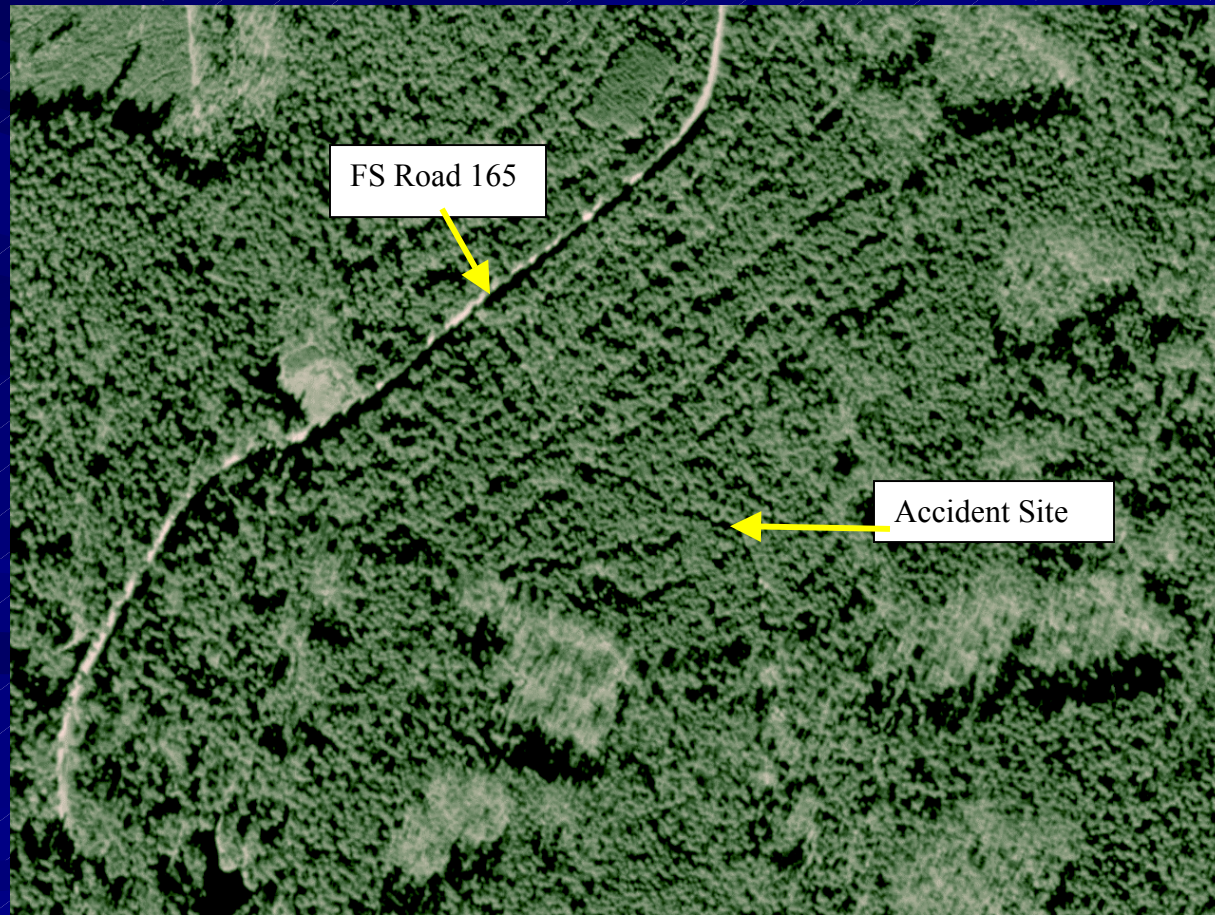
After 45 minutes of aerial ignition work, the PSD machine experienced a sphere jam, and the helicopter returned to H1 to resolve the problem. The helicopter shut down at H1 while the PSD machine problem was resolved.

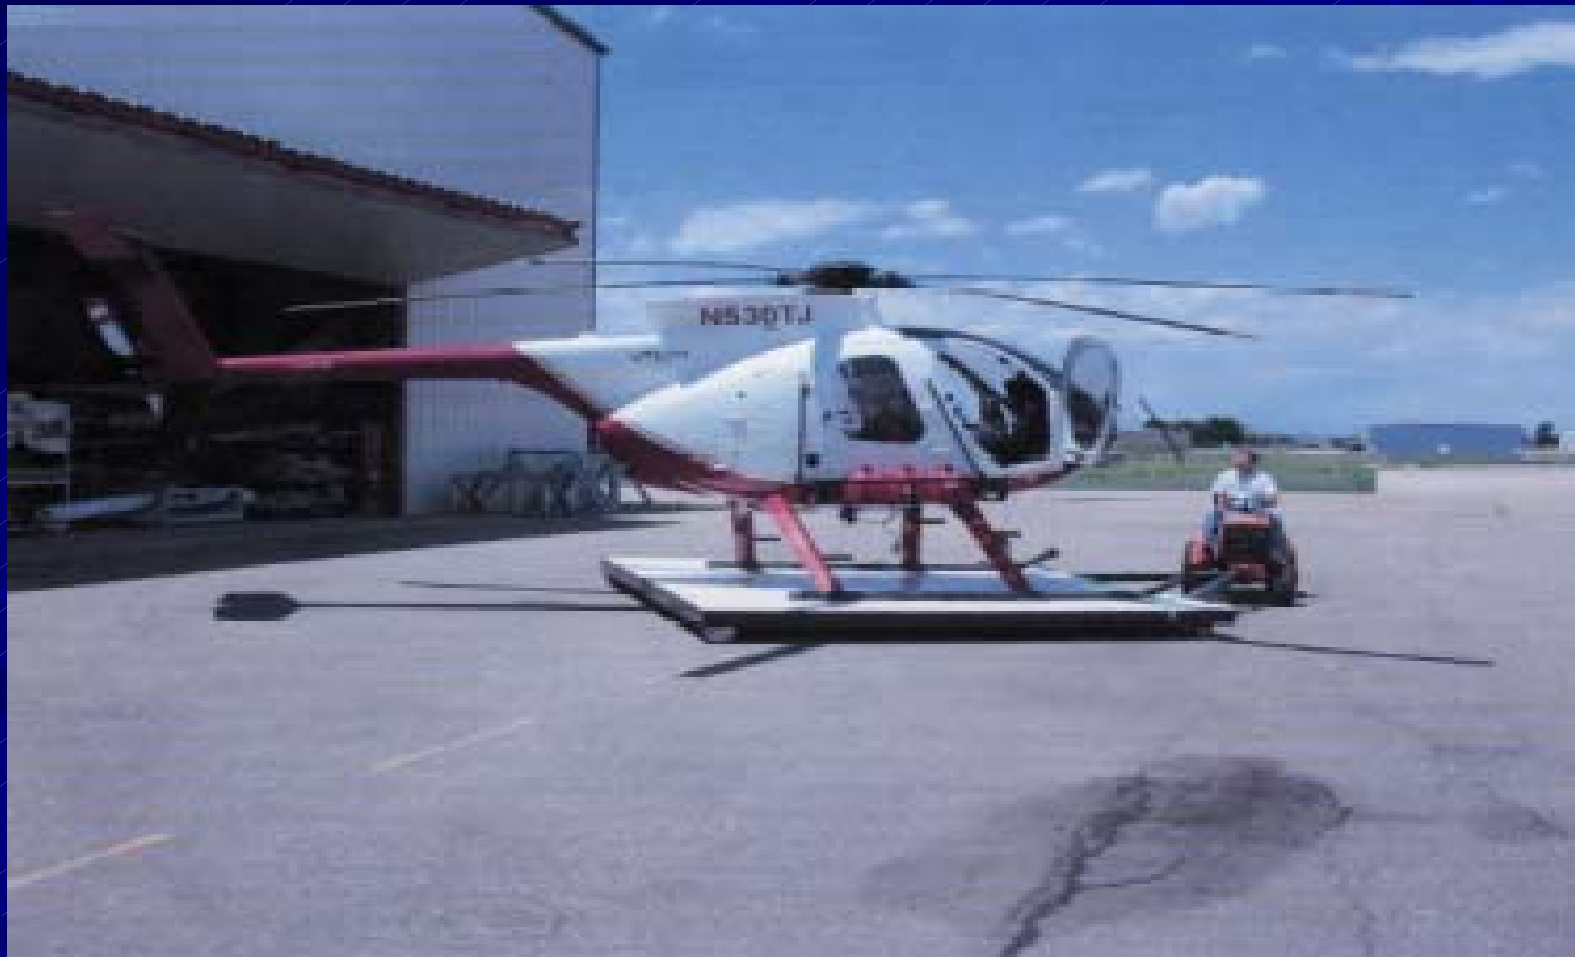
Accident occurred July 19, 2005 in Loveland, CO

Aircraft: Hughes 369FF, registration: N530TJ

Injuries: 1

Minor.Operational Control: Arapaho-Roosevelt NF

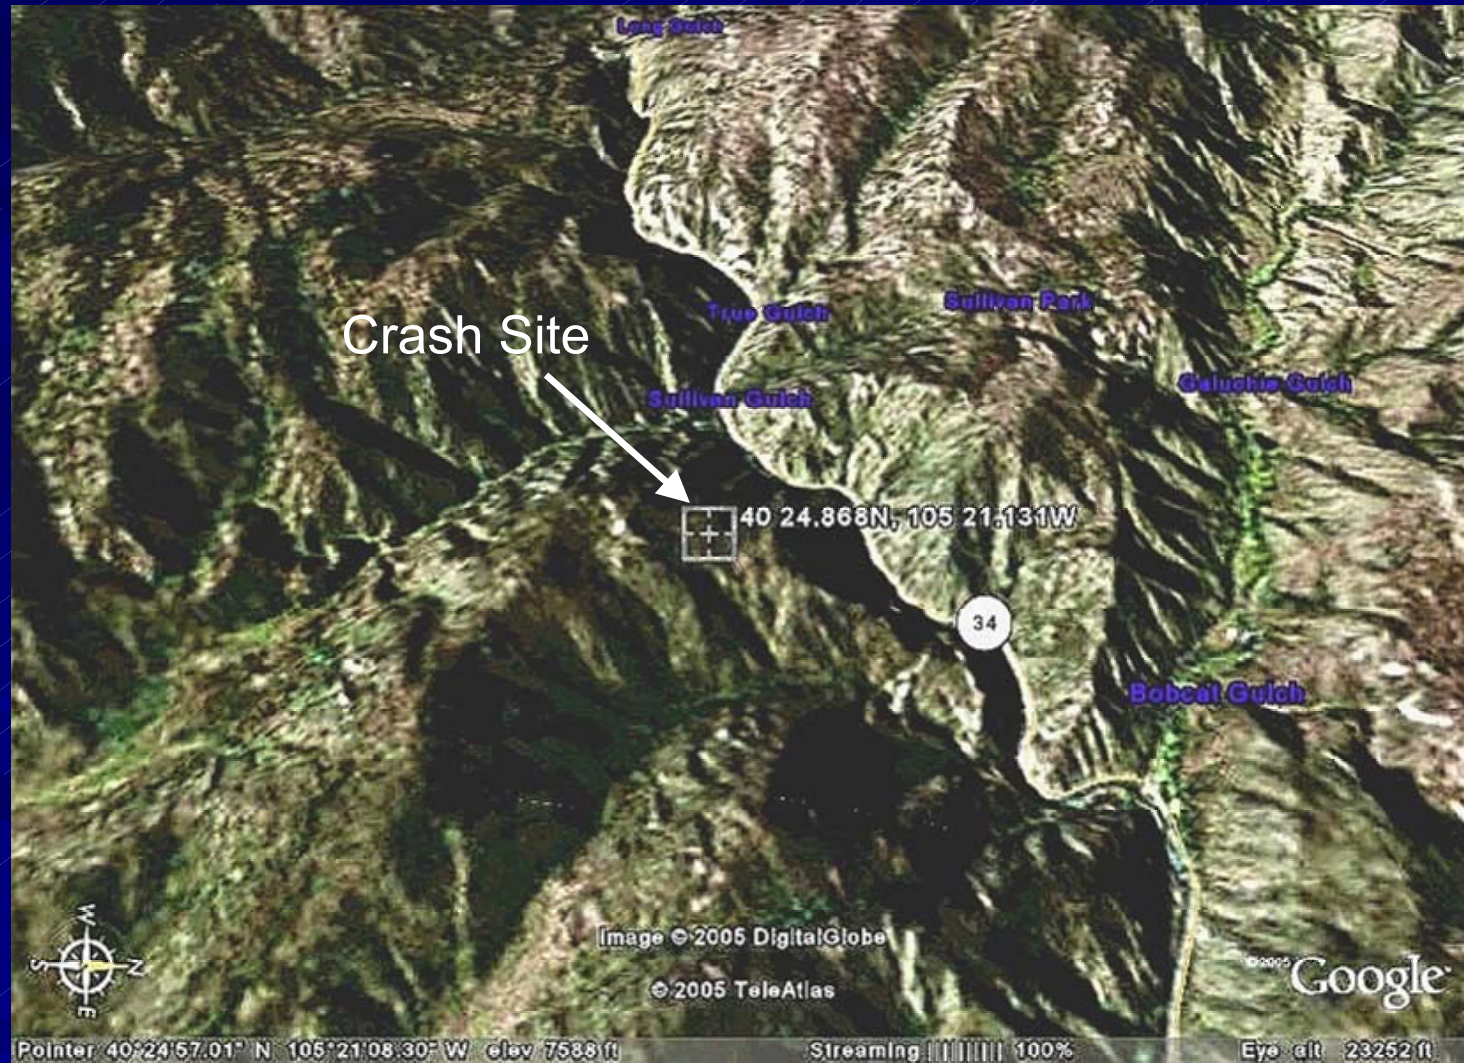
While on approach to the established drop site, approximately 100 yards away, the helicopter experienced an uncommanded yaw to the right. The pilot was unable to regain control and after several rotations crashed.

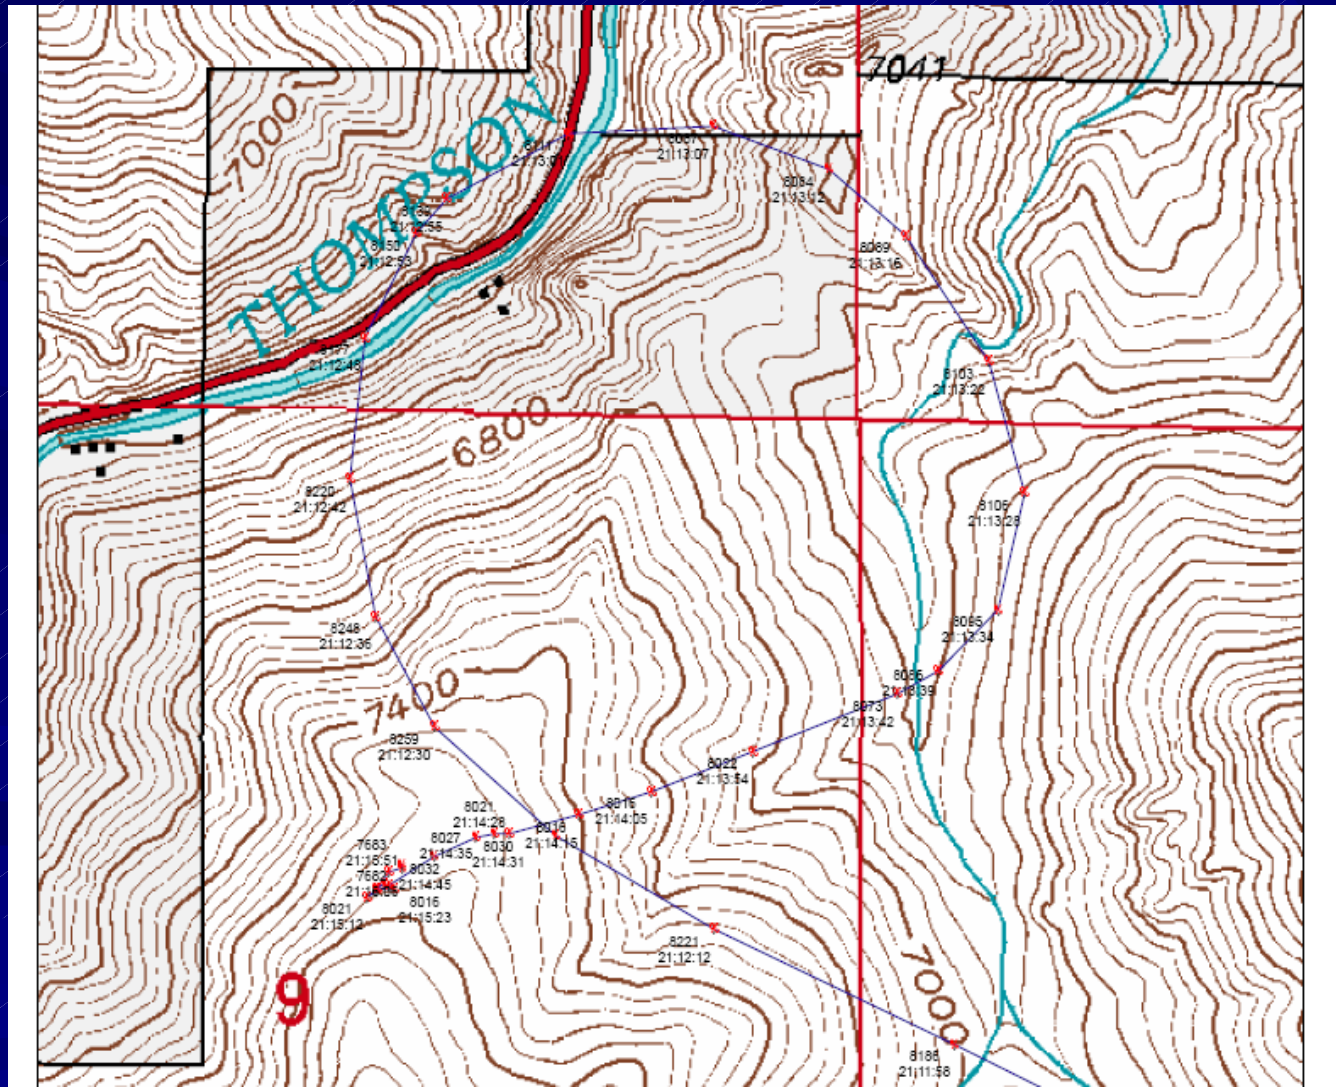
After the helicopter completed one 360-degree rotation to the right, the pilot released the external load, and lowered the collective in an attempt to arrest the right rotation.

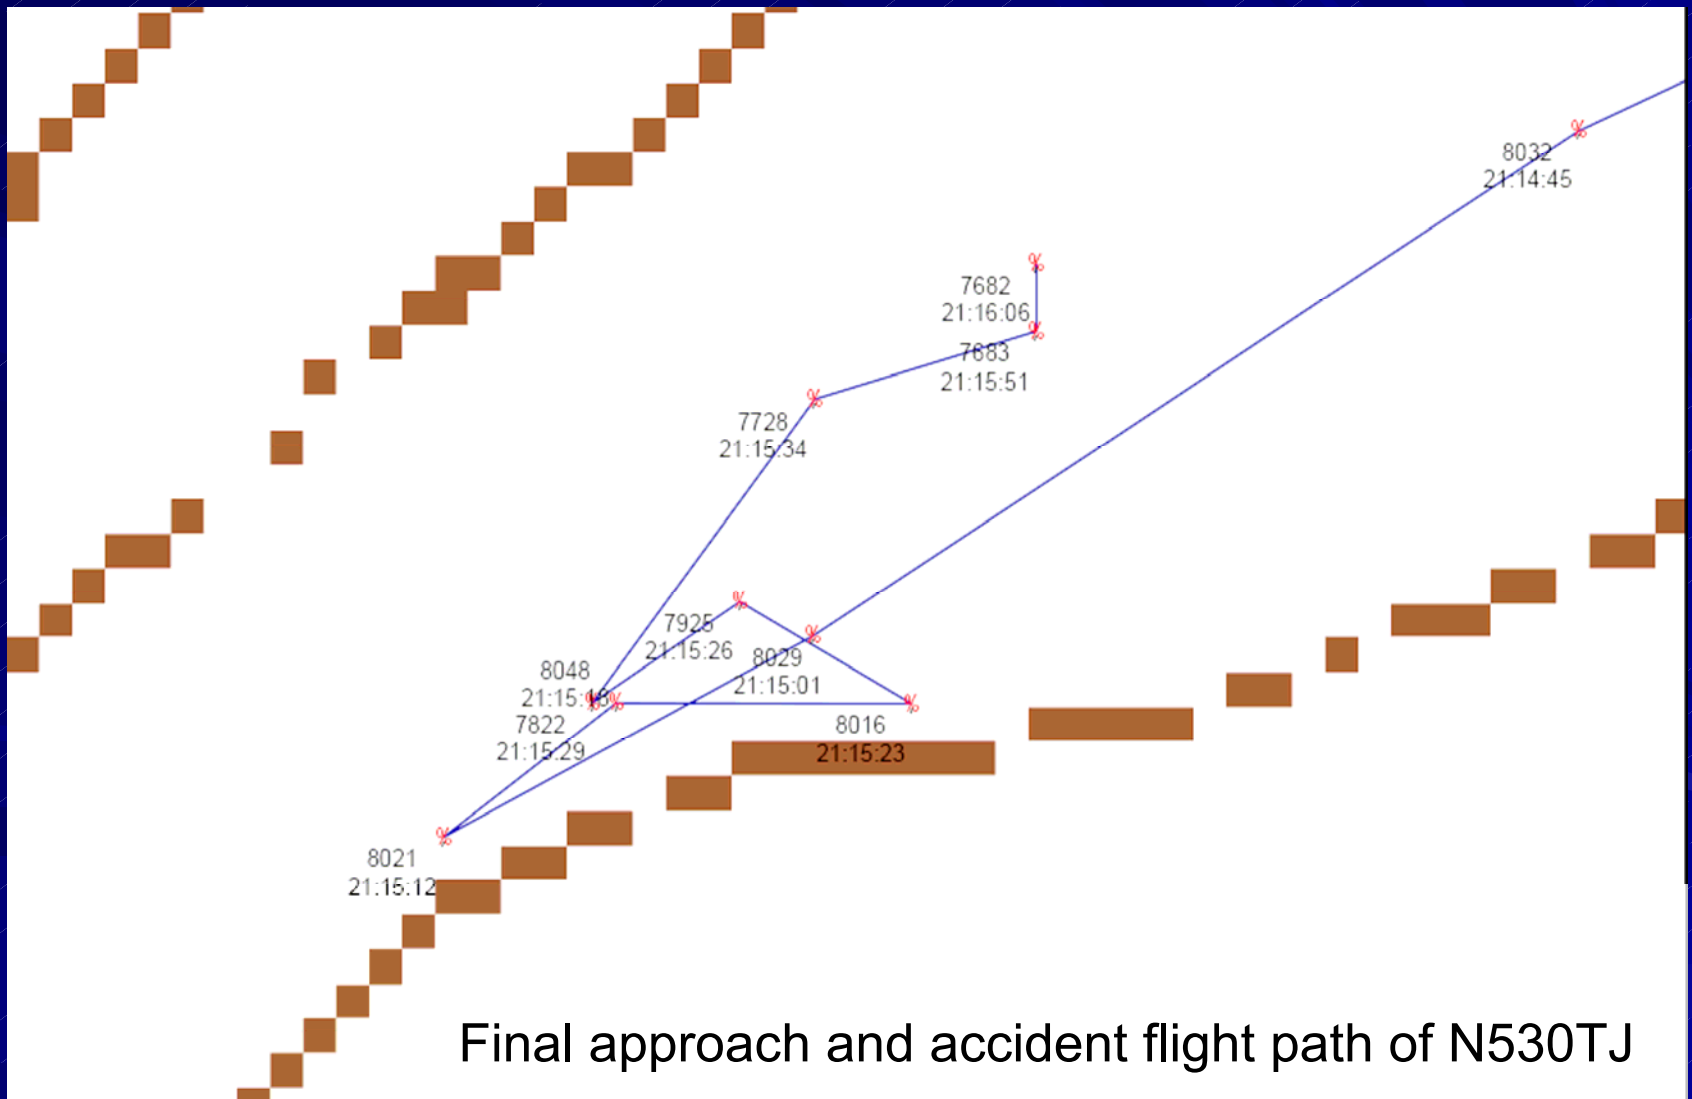
When the helicopter began to descend toward the trees, the pilot "pulled pitch." The helicopter continued to rotate to the right, between 5 and 7 rotations.

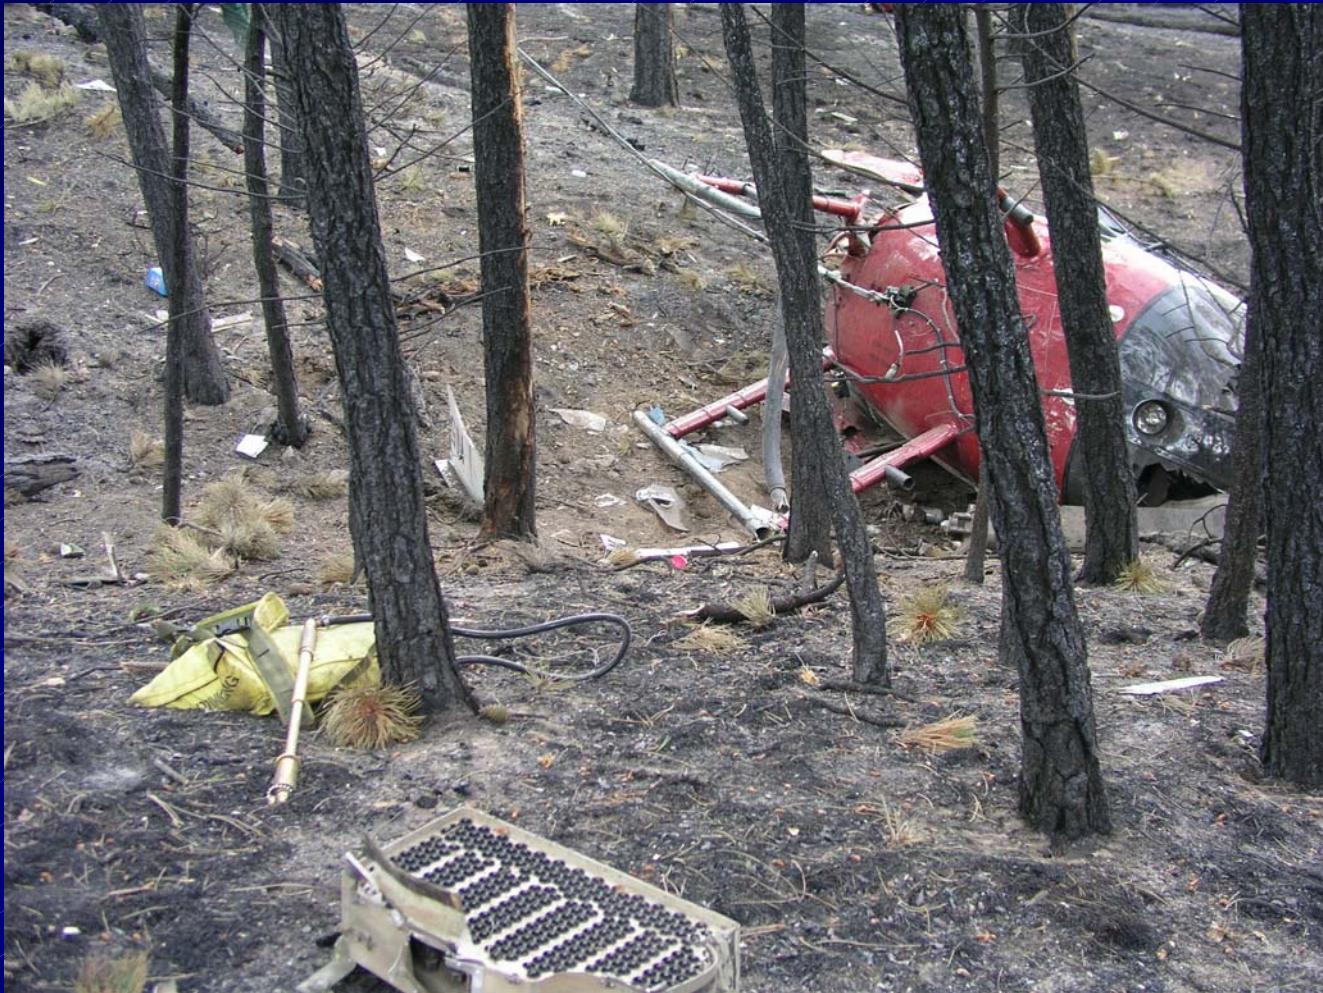
Witnesses who observed the accident stated they did not see any components separate from the helicopter prior to impact with trees and terrain. Initial analysis from McDonnell Douglas shows no mechanical failures with the aircraft.

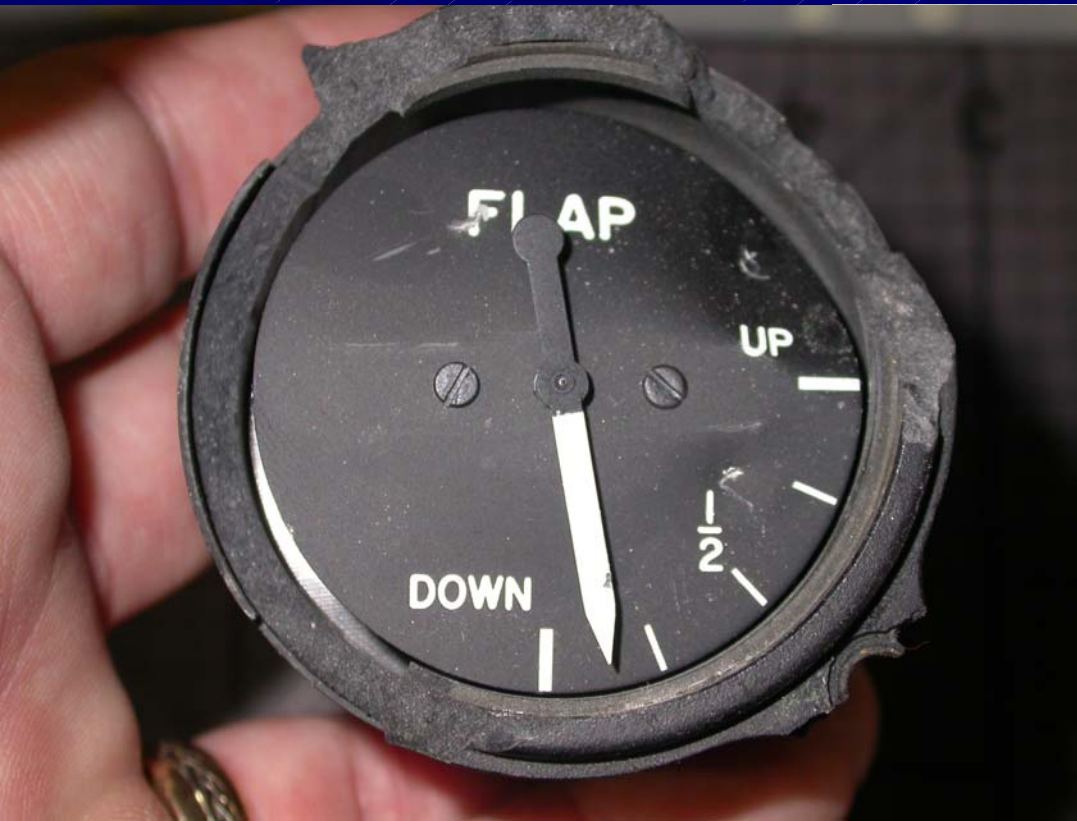
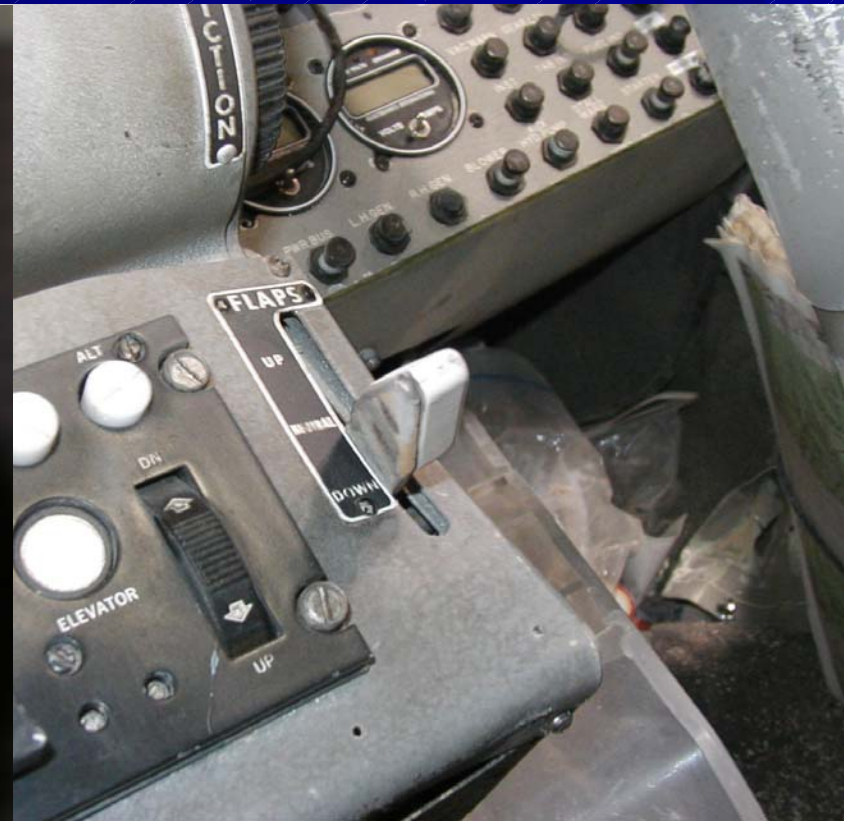
The flaps were measured to be at the 30-degree position. The flap actuator was measured and also corresponded to a 30-degree position. The flap indicator was damaged in the impact sequence but indicated the flaps were in the 30-degree position.

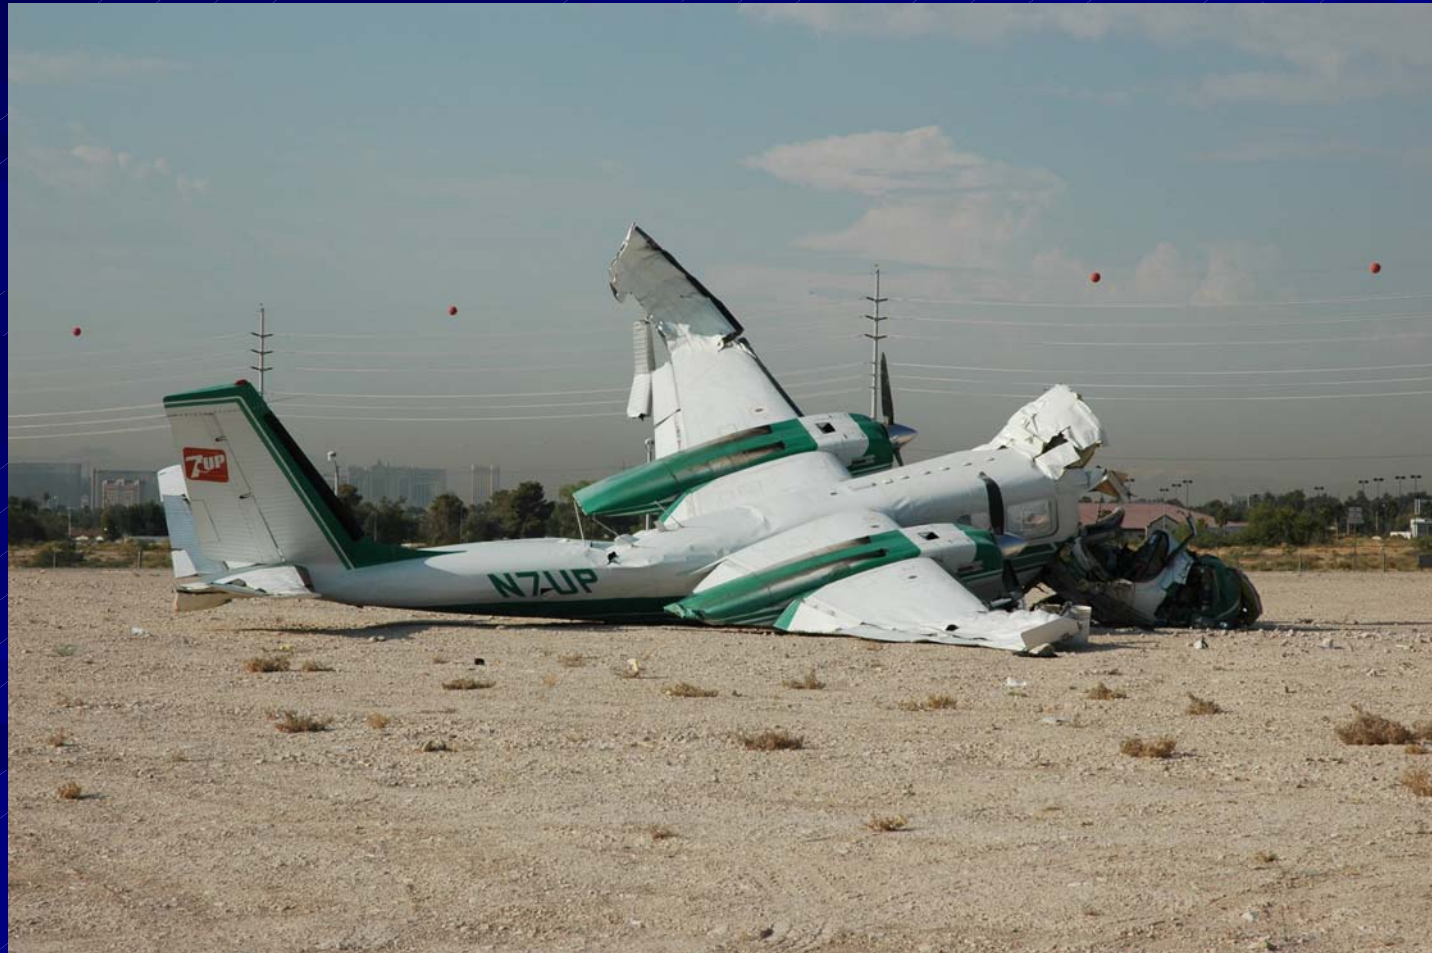
The airplane was destroyed and the pilot and one passenger sustained serious injuries; the second passenger sustained minor injuries. There was not crash and rescue on-site at North Las Vegas airport

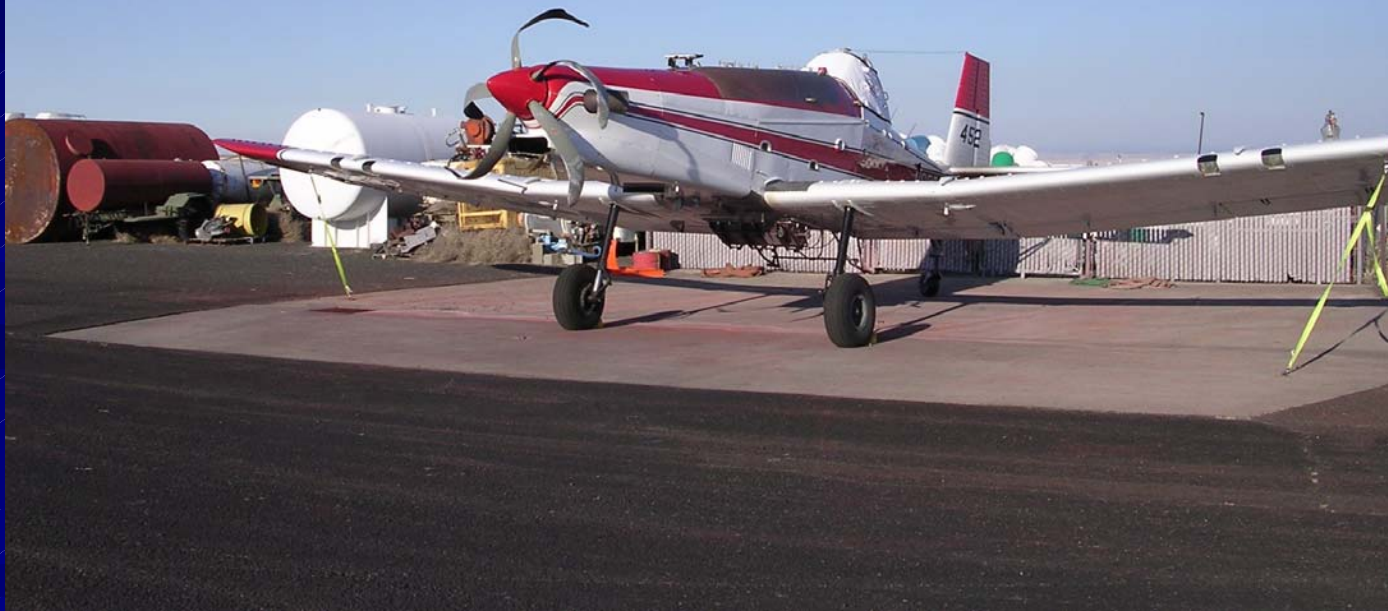
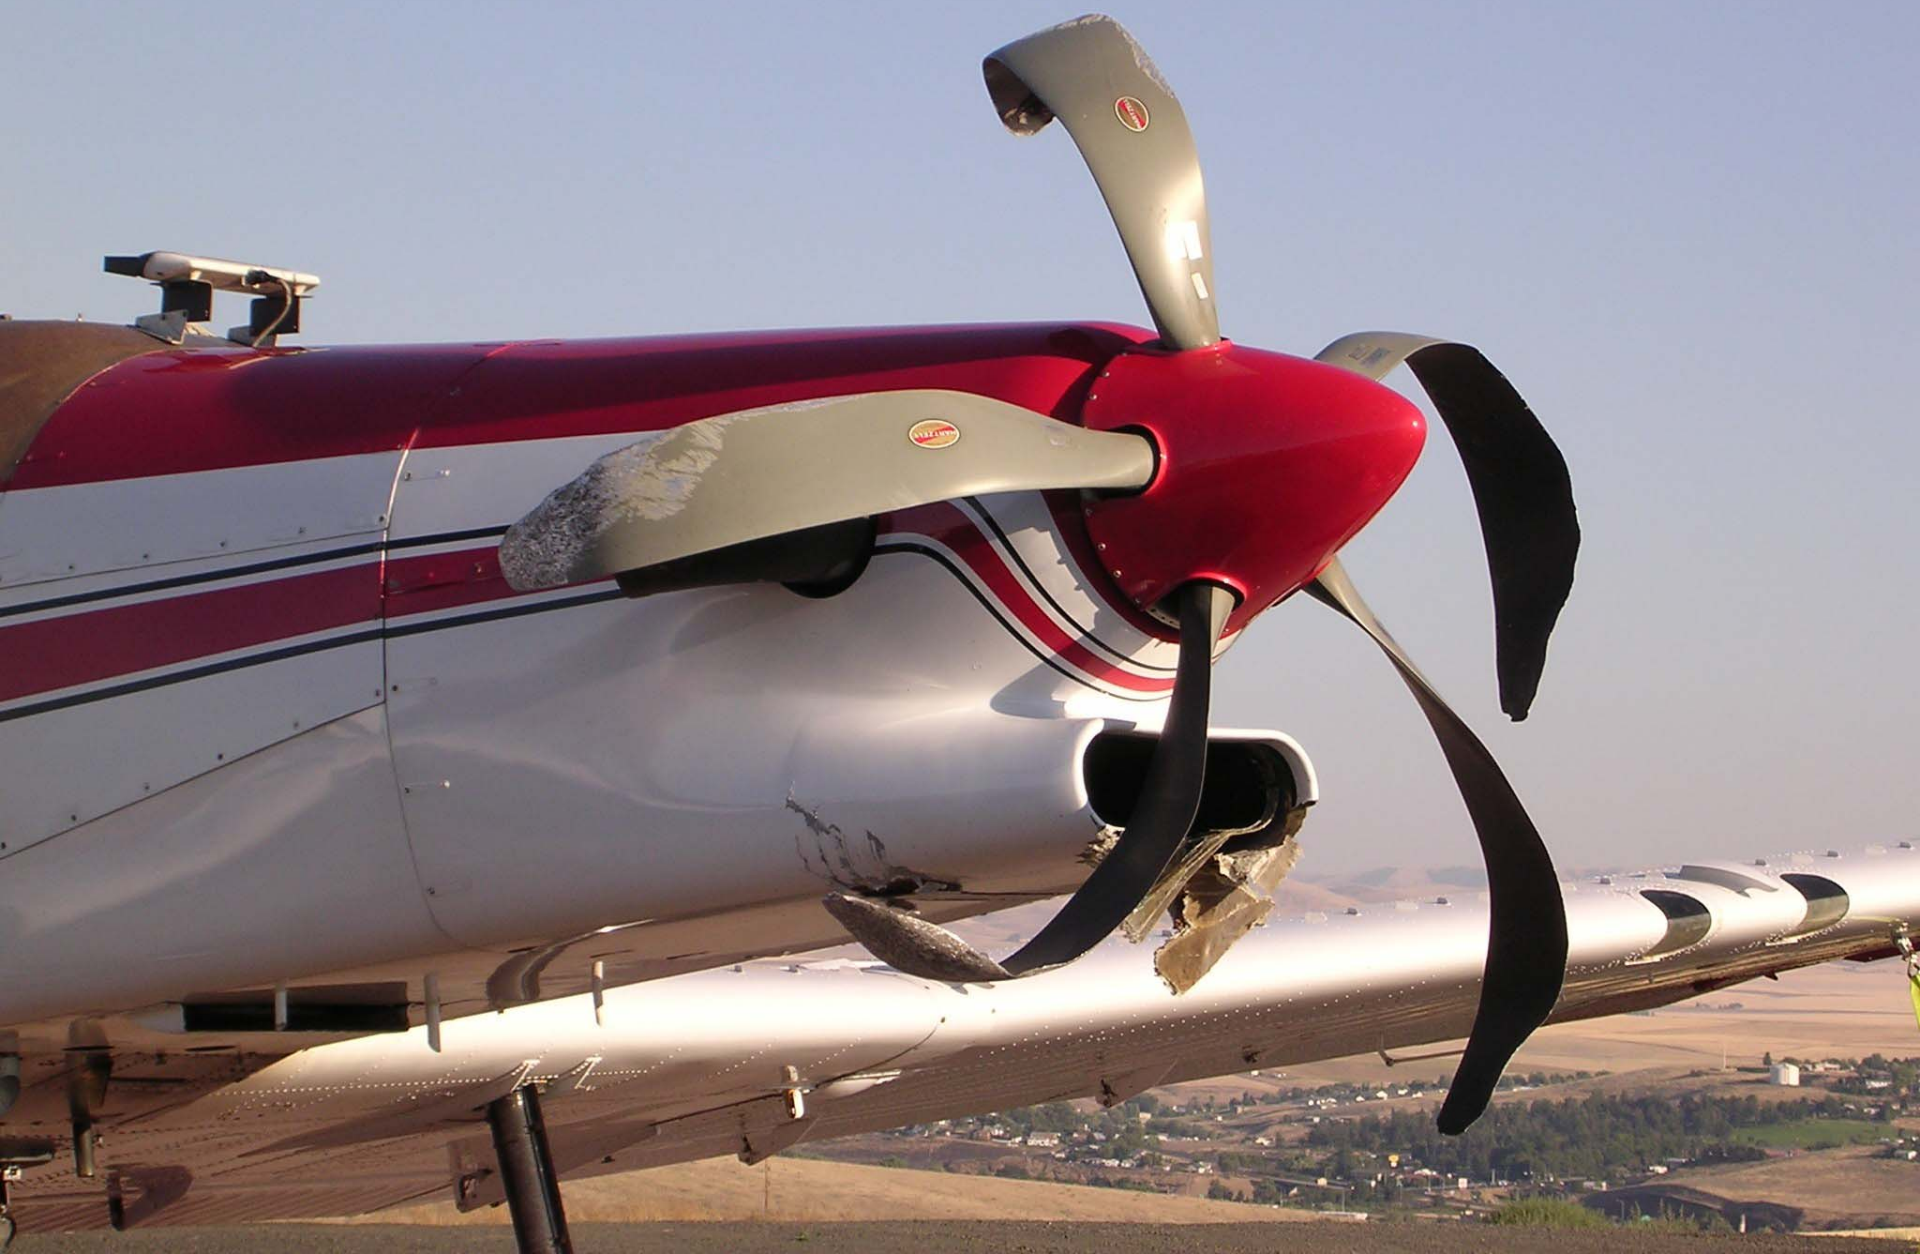
R-6 Umatilla NF Contract
Prop damage on landing
